Blok 59
Eindhoven
The Netherlands
19 floors

PRODUCT TEST

The objective of this test is to measure the descending time from a multi-storey building when using the S-CAPEPLUS and the abrasion resistance on the product's bottom side after descending multiple staircases. As a result of these findings, Tetcon and external parties can use the data to provide potential users with valuable insights on the product's qualities and the potential benefits it might have during an emergency evacuation.

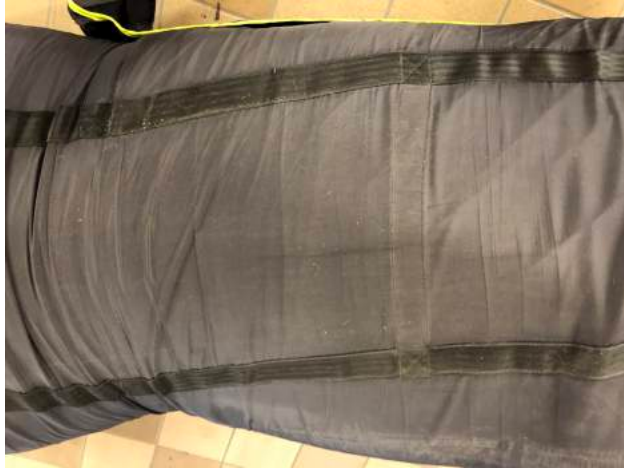
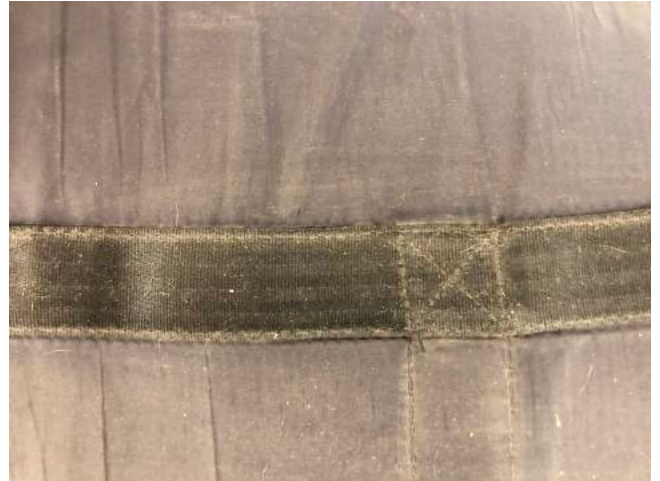
Test results after 19 staircases

Results after 19 staircases:

- The bottom side of the S-CAPEPLUS is covered with unclean substances (dust).
- No visible damages on the polyester bottom side of the S-CAPEPLUS.
- No visible damages on the stitches.

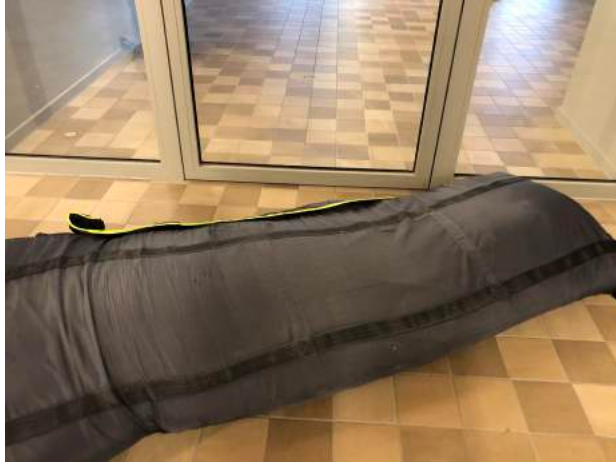
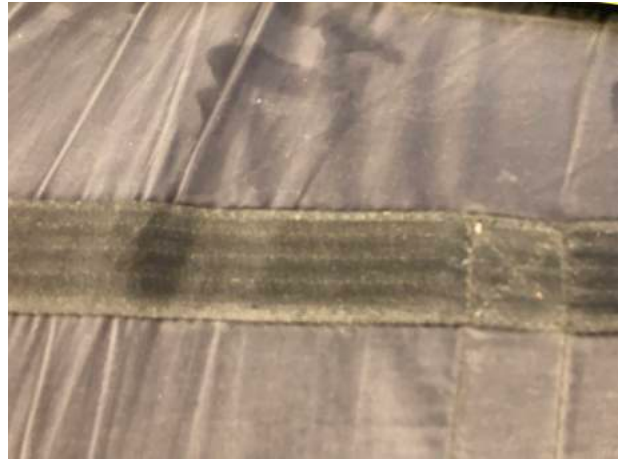
Test results after 38 staircases

Results after 38 staircases:

- The bottom side of the S-CAPEPLUS is covered with unclean substances (dust).
- No visible damages on the polyester bottom side of the S-CAPEPLUS.
- No visible damages on the stitches.

- The physical shape of the users will affect the speed of descending the staircase. Whenever user fatigue starts to kick in, it is advisable that users change their positions. Whenever there is only a single user, it is advisable to take some rest when needed.
- The S-CAPEPLUS was not damaged after 38 staircases.
- The S-CAPEPLUS can still be used after 38 staircases on this type of surface and under these circumstances.
- Sharp edges or protrusions may damage the S-CAPEPLUS.

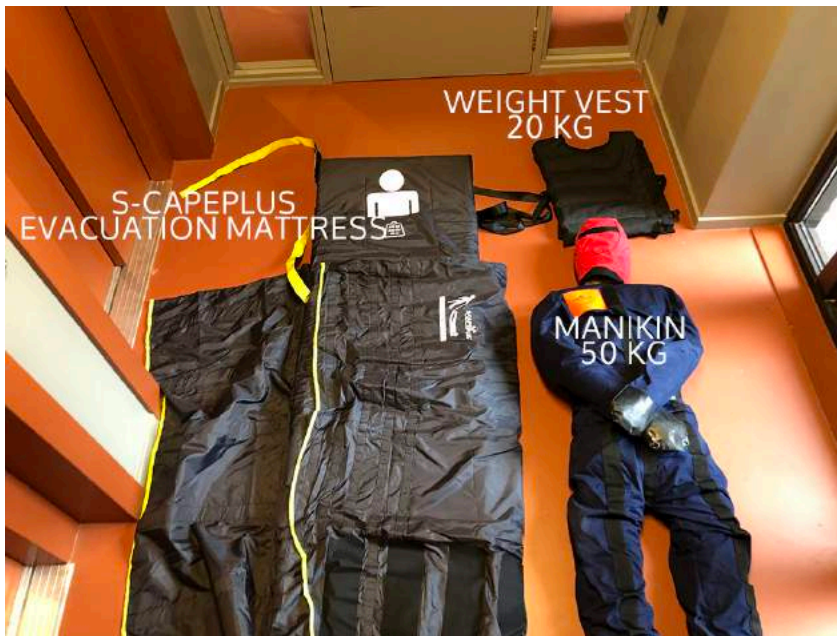
Appendix 2 – Materials being used for the test

The weight vest will be placed around the manikin's upper body and will then be placed onto the S-CAPEPLUS.

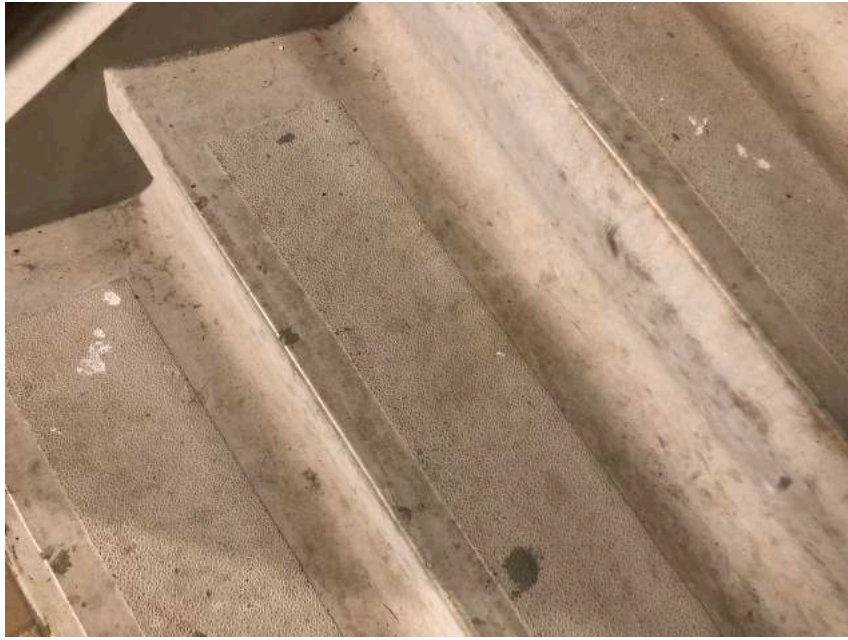
Appendix 3 – Staircase across 19 floors inside Blok 59

Location information	
Building name	Blok 59 – Strijp S (Appendix 4)
Address	Philiteaan 59, 5617 AK Eindhoven
Number of floors	19 floors
Number of steps per staircase inside the building	17 steps
Surface material on staircase inside the building	Concrete (Appendix 3)
